Power Back Door Does Not Close Properly

Service Category Vehicle Exterior

Section Door/Hatch

YEAR(S)	MODEL(S)	ADDITIONAL INFORMATION
2008 – 2012	Highlander, Highlander HV	WMI(s): 5TD, JTE

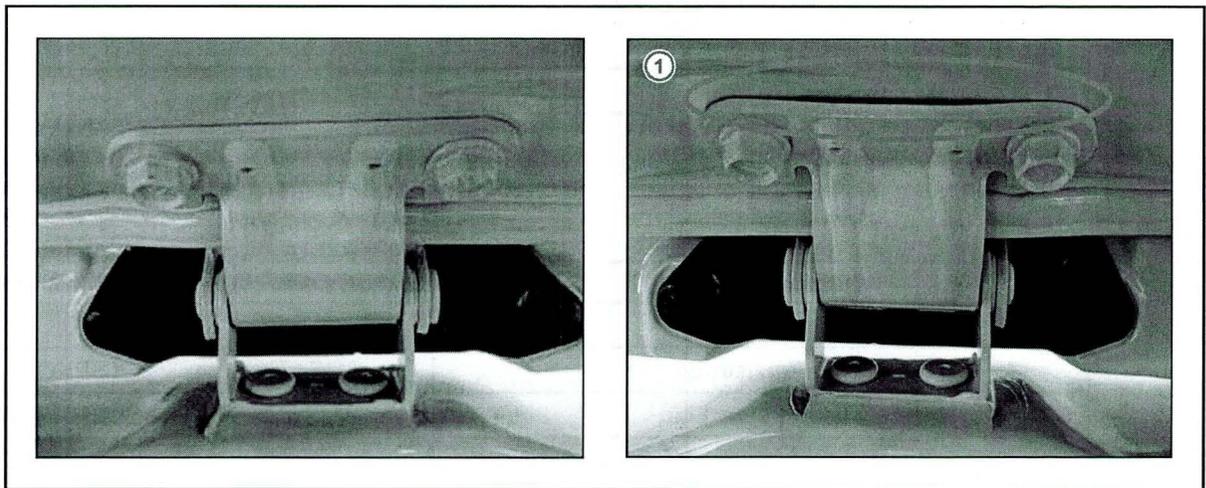
1. Inspect the upper hinges for any gaps present by placing a 0.05 mm (0.002 in.) or greater feeler gauge between the 2 bolts mounted to the back door as shown in Figure 1. If a gap exists, replacement of both Back Door Hinges AND the Back Door Panel Sub-assembly is required. Proceed to step 2.

1	Gap Location
---	--------------

Remove and replace the back door, hinges, and lift arm/Power Back Door motor as needed based off inspection procedures in this bulletin.

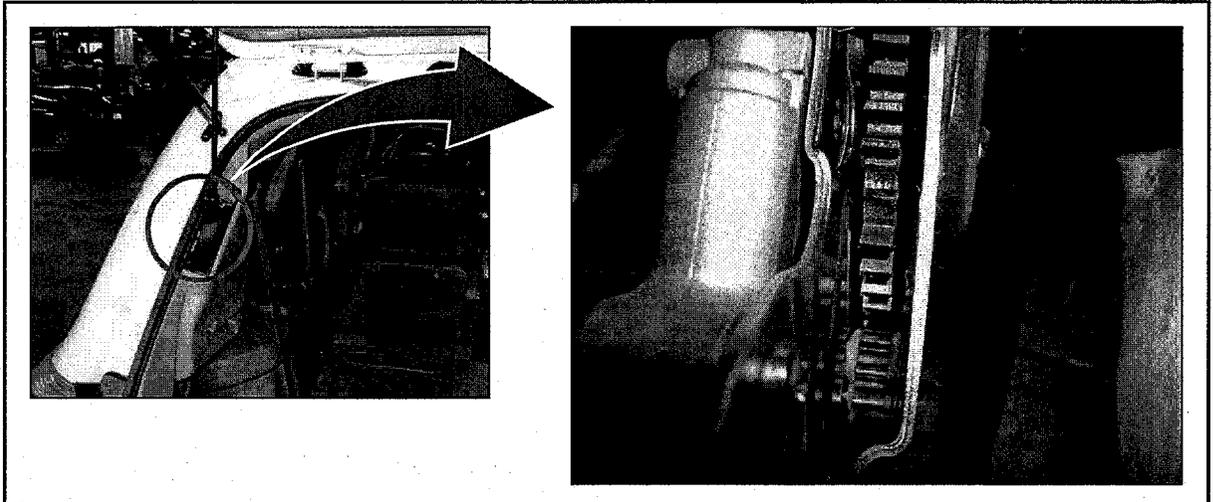
2. Visually inspect the back door motor teeth for damage by opening the back door and manually moving the door towards the half-closed position while observing the large gear teeth for damage, as shown in Figure 2. If damage is found, replacement of the Back Door Motor Unit is required.

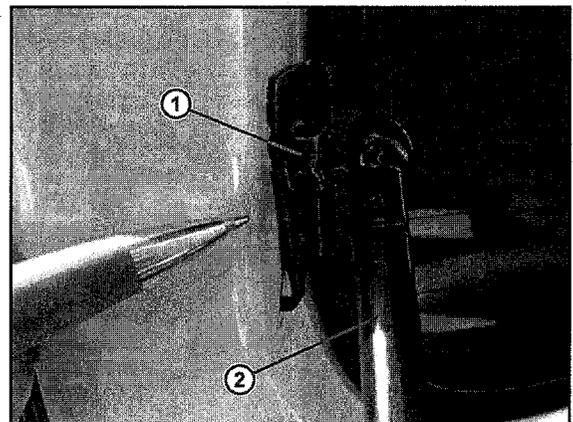
Figure 3.

3. Visually inspect the Back Door Upper Rod and Lift Arm Stud for bends or damage. If it is bent, or damage is found, replacement is required.

1	Lift Arm Stud
2	Back Door Upper Rod

The Back Door Upper Rod and Lift Arm Stud are available as separate service parts from the Back Door Motor Unit if found damaged or bent.
